## Report on Tornado & Severe Thunderstorm 19, December 2009

### Details of Assessment

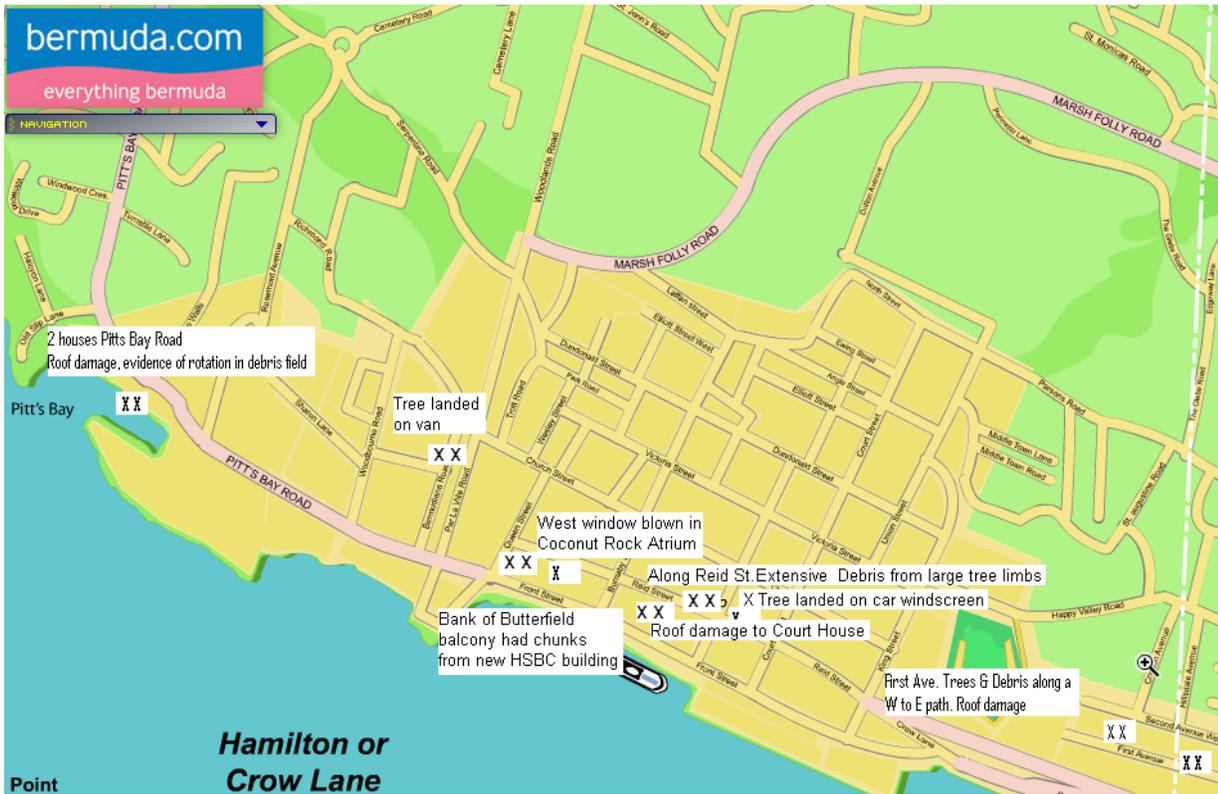
The conclusion based on our analysis of the Doppler radar data, the survey of damage and the input from various members of the public, is that this feature approached the northwest through north of Hinson's Island, came onshore at Pitts Bay Road as a tornado, travelled towards Reid Street, probably had a modified surface wind field due to the friction of buildings thus acted like a straight line wind even due to the tunnelling of the wind down Reid Street, as it hit Cavendish Heights it could have had rotation at that elevation (not certain as debris did not confirm this). It looks like the damage at Devonshire Bay was from a different thunderstorm cell based on the paths of the cells and timing of damage. This most likely was due to straight line winds as the debris is orientated in line with the forecast and observed wind direction, from SW to NE. It is difficult to judge the category of tornado due to the standard descriptions of damage being related to United States building structures, and Bermuda roof construction is extremely different. It would require less force to tear off a US style roof compared with Bermuda construction. As it stands I can estimate the tornado to have been between EF1 and EF2 due to these categories claiming "Heavy roof damage to homes and businesses, large tree limbs snapped off".

Figure 1: Path of suspected tornado and locations of resulting damage in Hamilton

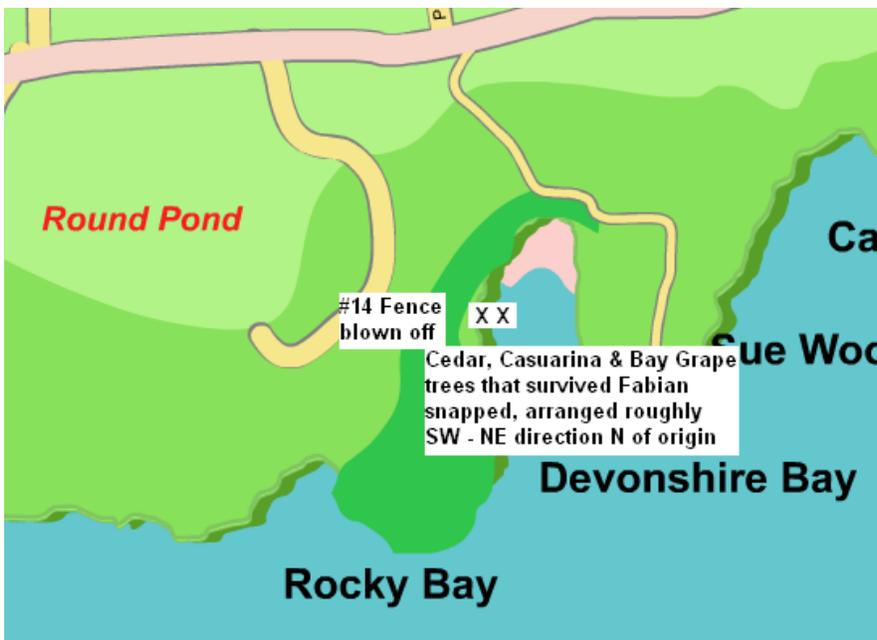
Figure 2: Path of suspected tornado and locations of resulting damage in Devonshire Bay

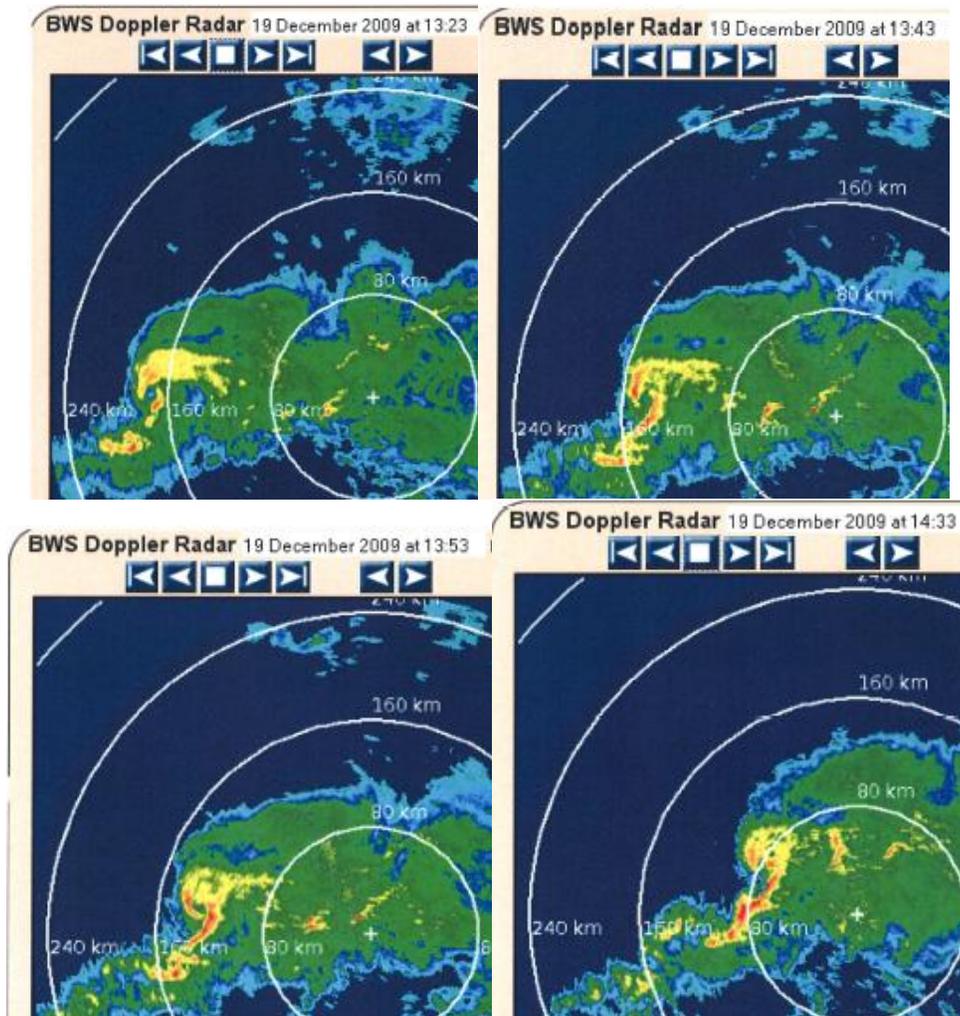
- **13:23 December 19<sup>th</sup>** Radar image showed signs of rotation 180 km to the west – Duty forecaster calls Deputy Director to discuss. It is agreed that if they show signs of strengthening, a Severe Thunderstorm Warning will need to be issued.

Figure 3: Watching the rotation form on the thunderstorms 180 km west of Bermuda (times are local times)

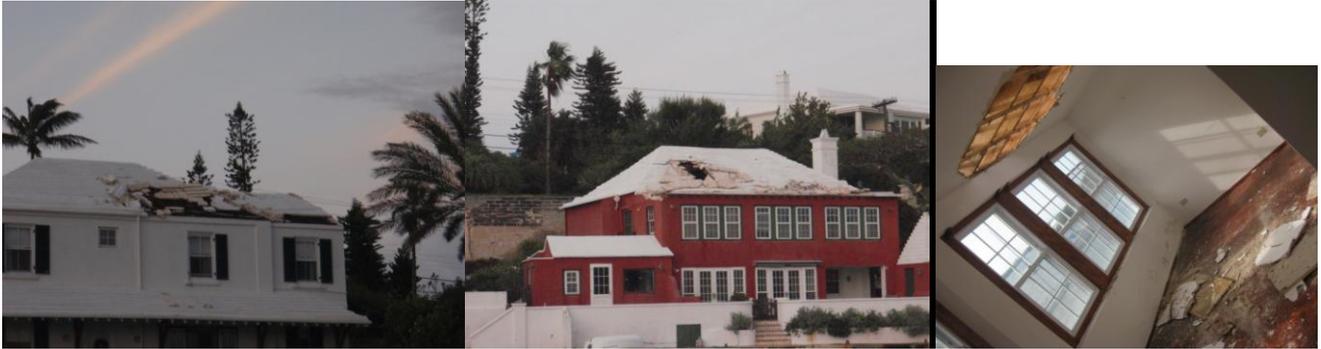
Figure 4: Roof damage at Pitts Bay Road, Hamilton, Pembroke

During Sunday 20<sup>th</sup> December further investigation was carried out along **Pitts Bay Road**, by the Deputy Director (figures 4 & 5). It was at these homes that evidence of rotation in the debris field was observed. Large chunks of the roof (not able to be picked up by a man) were found in an outside stairway approximately 20 feet W through NW of the origin. A straight line wind would have scattered the debris to the NE. A blind in the lee side of the red house was twisted off leaving a fraction of it still attached to a hinge (see photo). The push-out hook for the blind was located not only on top of the roof but south of the window of origin. Teak table and chairs on the S side of the house were scattered around the E through N side of the building. A large tree limb was oriented in a SE through NW direction. A quick glance at the weather sensor data from the Davis instruments on Hinson's Island showed a peak wind of 64 knots over a 5 minute time span around the time of the suspected tornado, and a rapid drop in pressure (see Figure 8.)

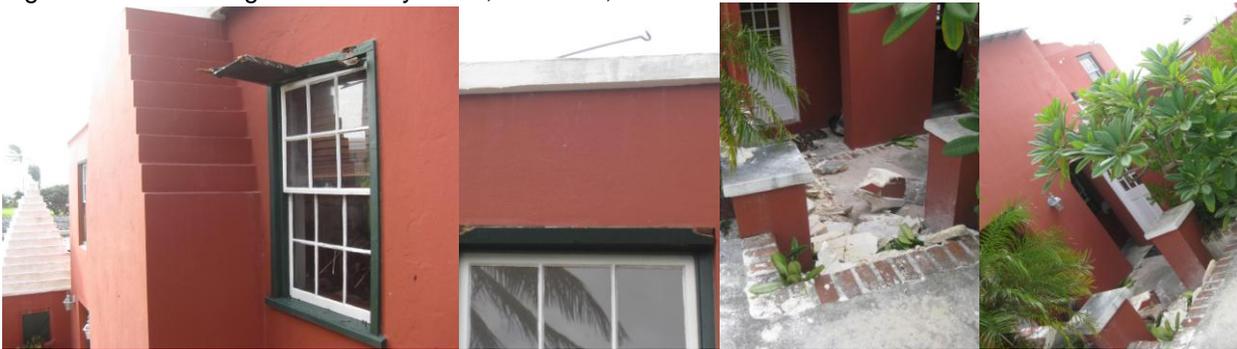
Figure 5: Evidence of rotation: torn blinds on the lee side of Pitts Bay Rd House, Blind hook found on TOP of house (behind and above original location), chunks of roof found 20ft SW of origin

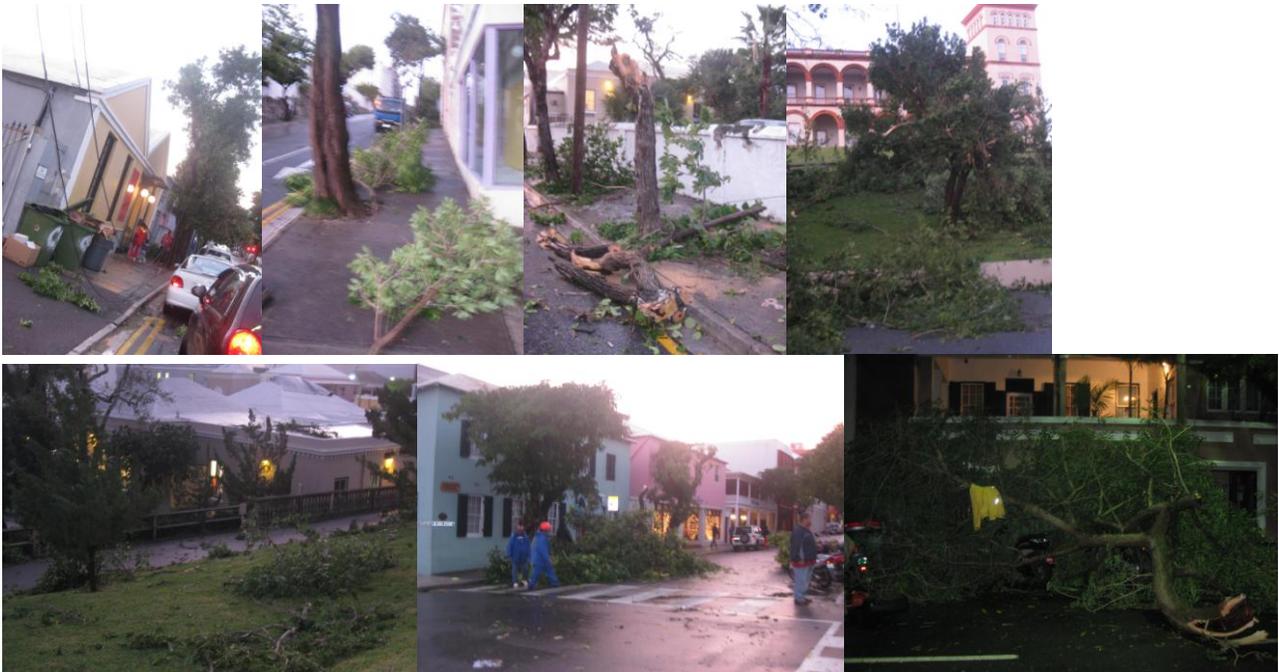
In the **City of Hamilton** the first evidence of damage were large limbs of trees strewn across Reid Street. (Figure 6.) Power lines were down outside of Chopsticks; the roof on the main entrance to Magistrates Court (corner of Parliament and Reid Streets) was damaged and covered by tarpaulin by the time we got there (around 5:30pm). Buildings Superintendent Stephen Tucker (Min of W&E) indicated that it was likely because of the impact of debris/missiles carried in the wind, rather than direct damage done by the wind itself. Pedestrians and motorists had dragged lots of large tree branches off the road and onto the sidewalks along Reid St, from Parliament St. to Burnaby Hill to enable traffic to flow through the city. However there were some that were too heavy to lift and thus were broken down into manageable pieces by chainsaw. Some large limbs had fallen onto bikes, knocking them over, or otherwise trapping them and making them inaccessible to their owners to remove. There were unconfirmed reports of parked bikes on Reid St. being scattered by the wind, and two cars being heavily damaged by tree branches (one by the General Post Office), but not in evidence when we got there (perhaps towed/driven away already). The building next to Chancery Lane had some roof damage (20 X 5 feet according to high-lift & truck operator, who was assisting in the securing of the roof). Apparently the area around Joell's Alley took some damage also (unconfirmed). The Coconut Rock building had one pane of their west-facing atrium windows (top floor) blown/impacted in. Later we had a witness contact us to say that there was damage to the new HSBC building under construction and that the debris landed on top of the Royal Gazette building and the balcony of the Bank of Butterfield.

Figure 6: Fallen Tree Limbs, Reid Street, Hamilton, Pembroke

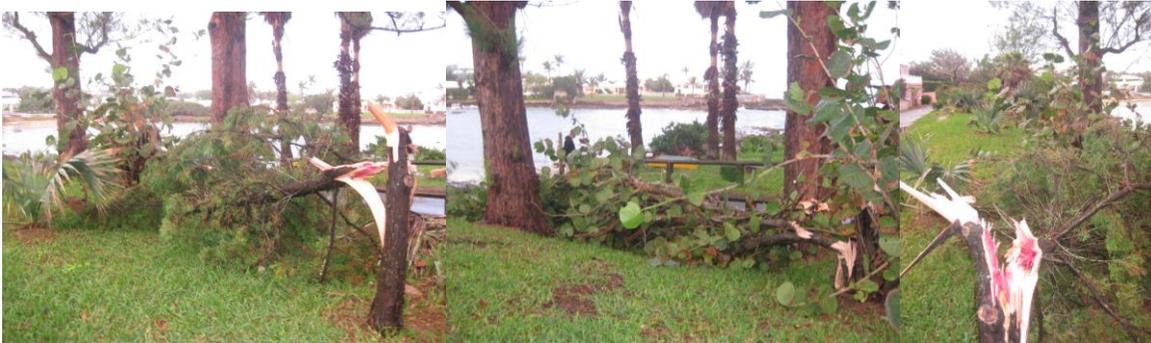
At **Devonshire Bay** several tree branches were blown down (figure 7), all facing the same direction, NNE from the point of origin. A small cedar tree was snapped off three feet from the base. Minor structural damage occurred as a fence was blown off at 14 Devonshire Bay Rd. The residents of #14 mentioned that the casuarina trees affected by this wind damage had withstood several hurricanes, including Fabian. This evidence supports the idea of a large short-term increase in wind speed (i.e. the suddenness of a squall or a microburst).

Figure 7: Fallen Trees, Devonshire Bay, Devonshire
